REMOVAL ACTION REPORT

PCB CONTAMINATED SOIL

USACE South Pacific Division Laboratory

Sausalito, California

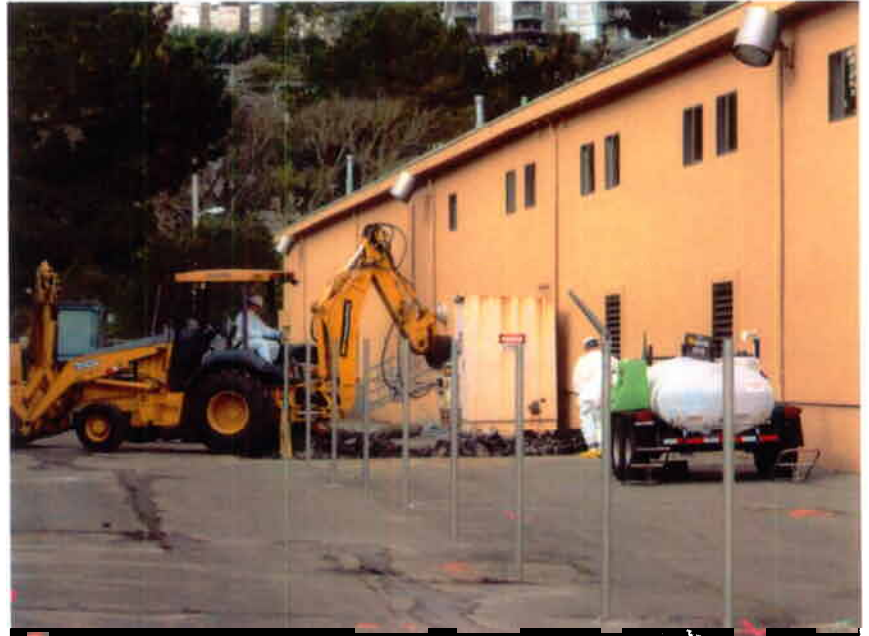
Photograph No. 001

Using breaker to break 12-inches thick asphalt pavement over excavation EX1.

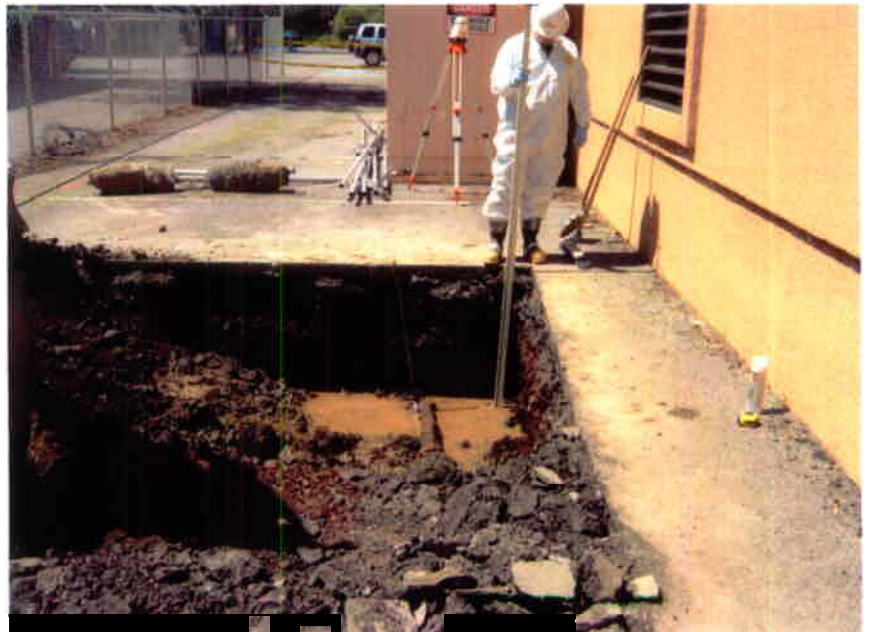
Photograph No. 002

Measuring depth to water encountered in EX1 (approximately 38 inches below ground surface).

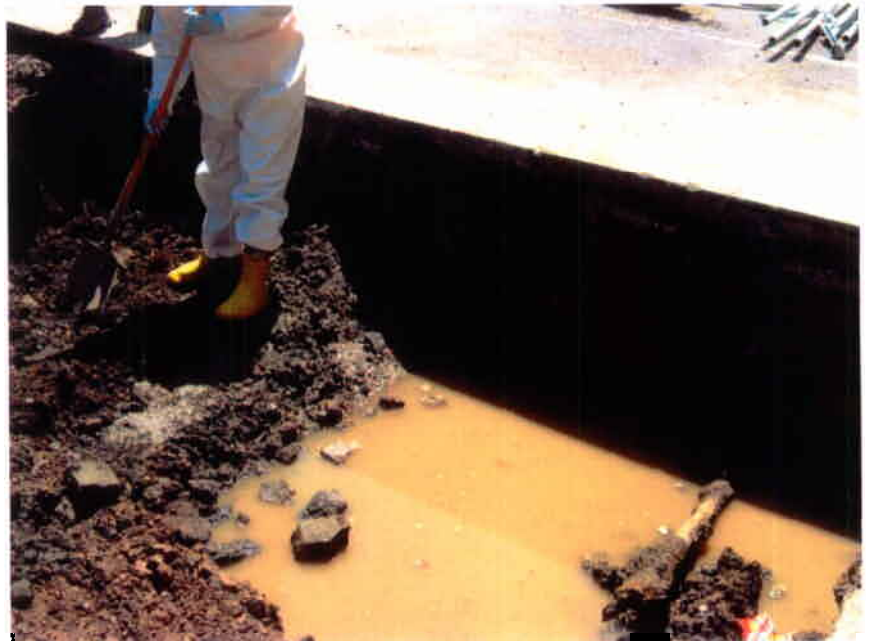
Photograph No. 003

Evaluating if water encountered in EX1 is groundwater or water from leaking pipes. Hole dug to the southeast also had water at 38 inches below ground surface which indicates groundwater rather than water from leaking pipes.

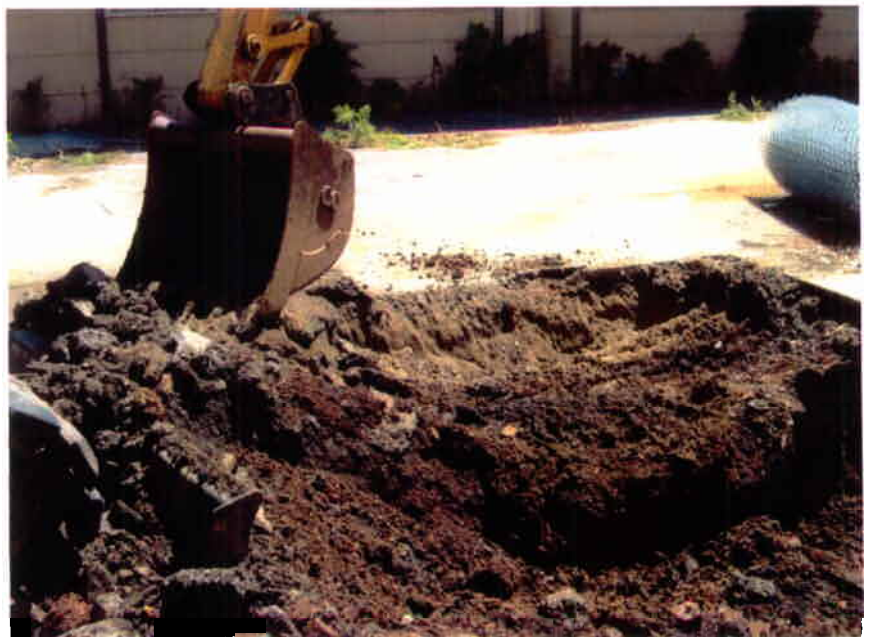
Photograph No. 004

Continuing to excavate EX1.

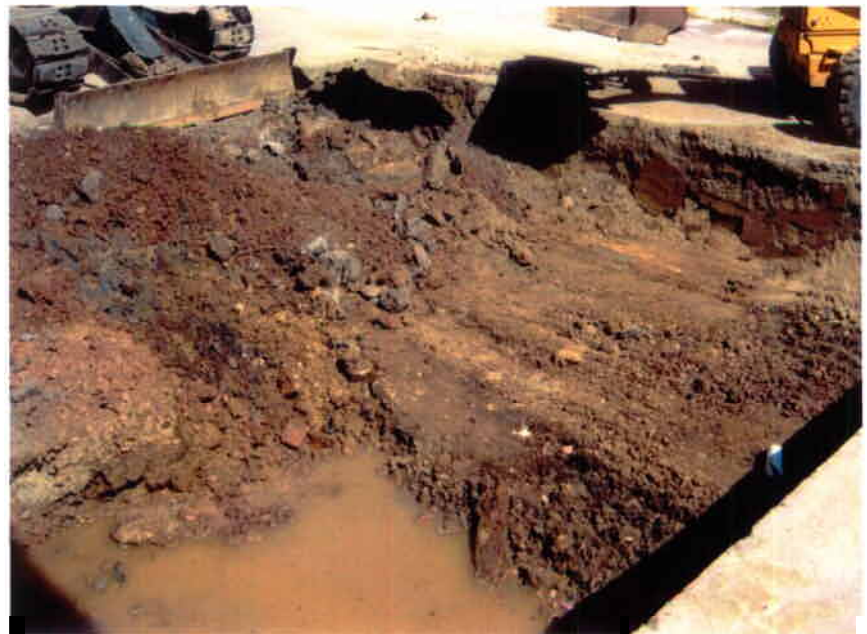
Photograph No. 006

Excavation EX1 excavating to six inches above encountered groundwater.

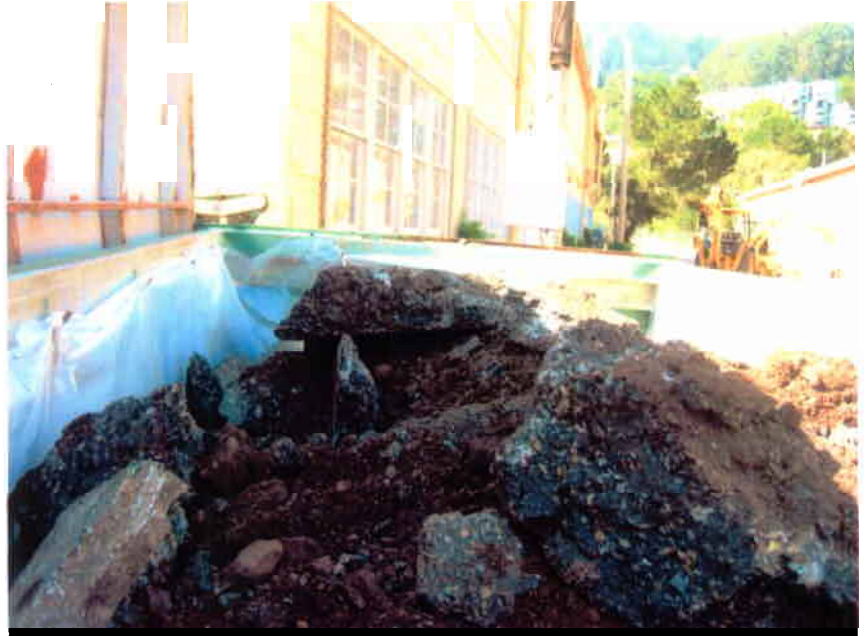
Photograph No. 007

Asphalt pieces in bin showing thickness of asphalt (12 inches thick) encountered at EX1.

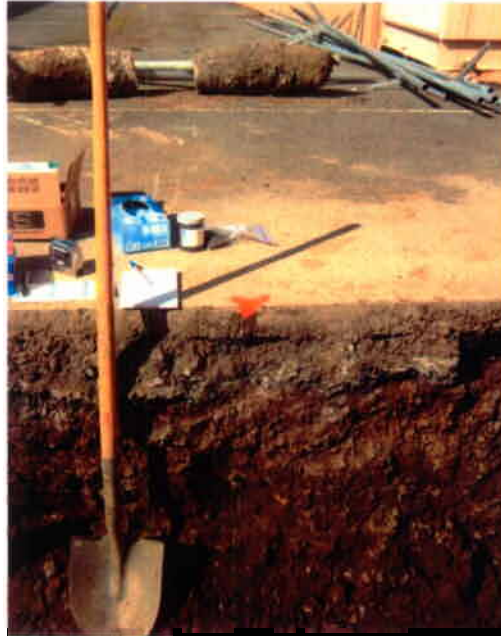
Photograph No. 009

Sample location EX1-1 (west wall) at 14 inches below ground surface.

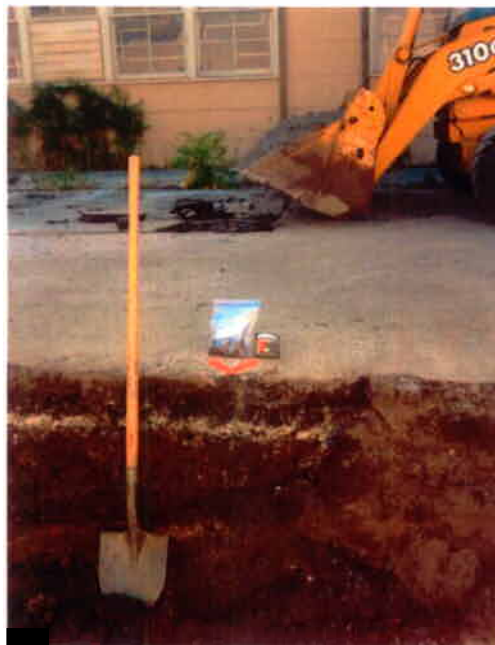
Photograph No. 010

Sample location EX1-2 (south wall) at 14 inches below ground surface.

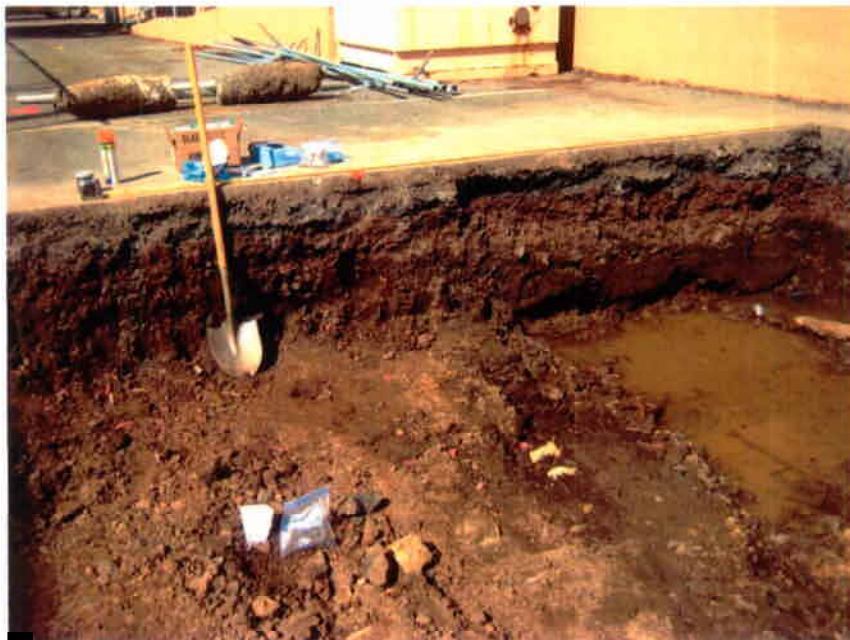
Photograph No. 011

Sample location EX1-6 (floor southwest) at 32 inches below ground surface.

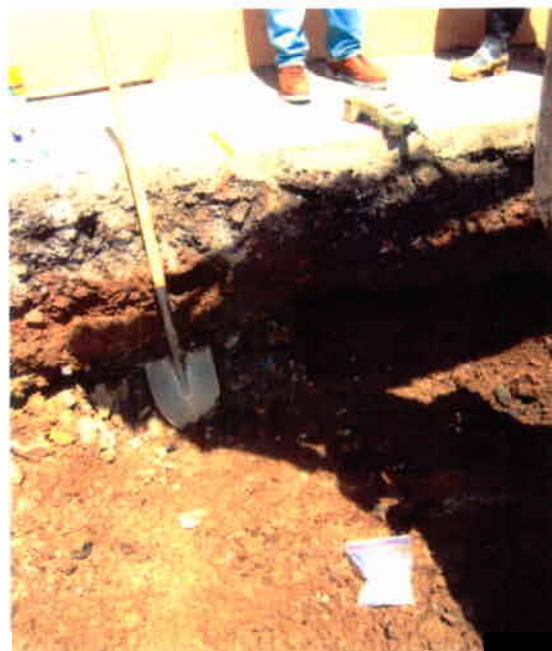
Photograph No. 012

Sample location EX1-5 (floor northeast) at 32 inches below ground surface.

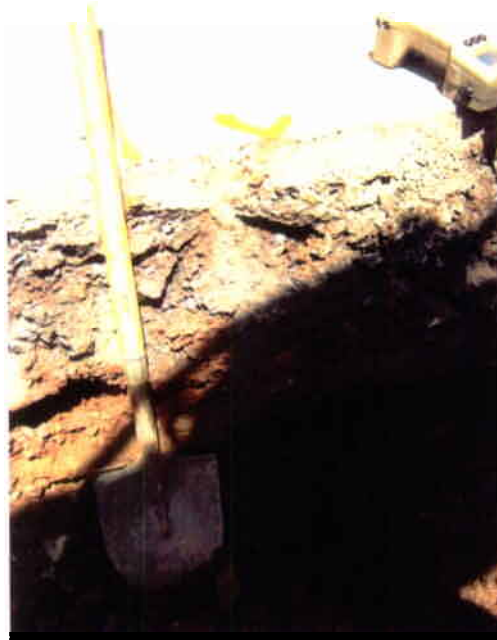
Photograph No. 013

Sample location EX1-4 (north wall) at 14 inches below ground surface.

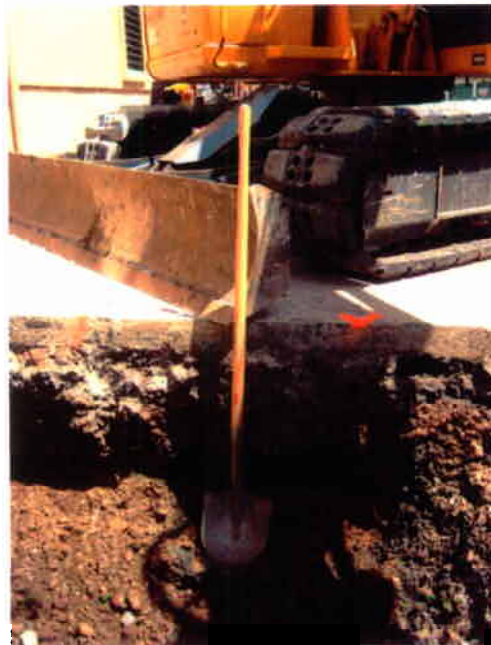
Photograph No. 014

Sample location EX1-3 (east wall) at 14 inches below ground surface.

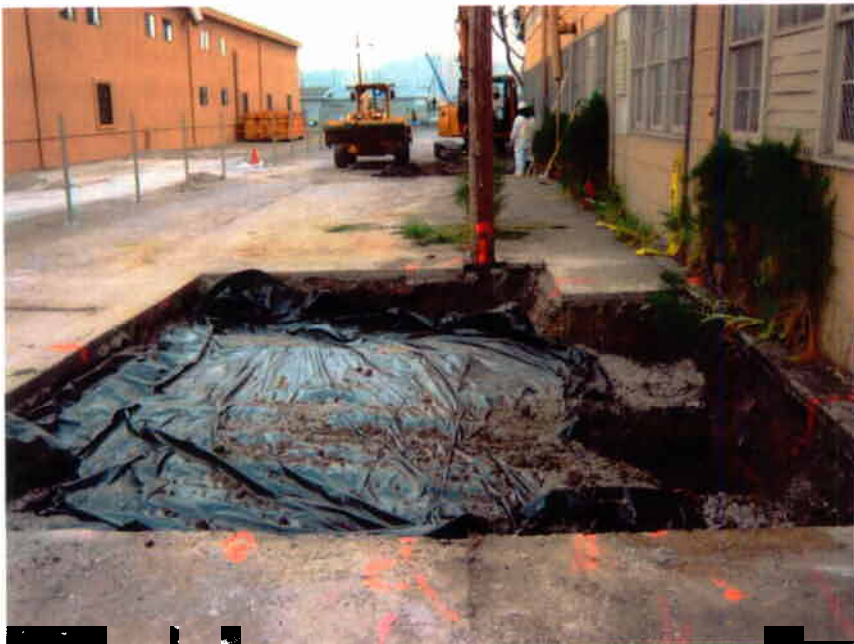
Photograph No. 016

Excavation EX2 being covered for weekend.

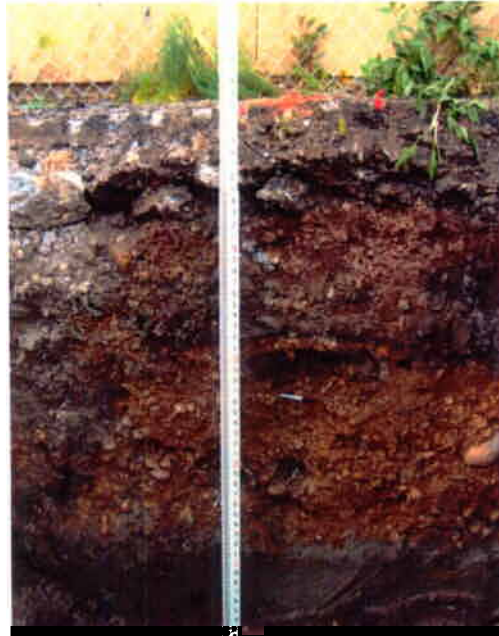
Photograph No. 017

Sample location EX2-3 (EX2 south wall) at 24 inches below ground surface. Also showing bay mud encountered at approximately 4 feet below ground surface.

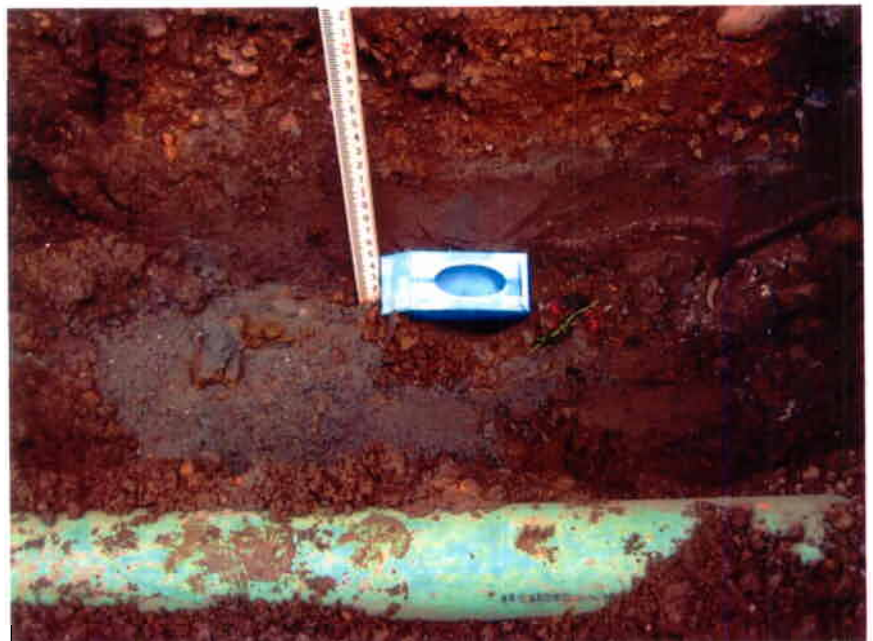
Photograph No. 018

Sample location EX2-6 (floor south) at 48 inches below ground surface.

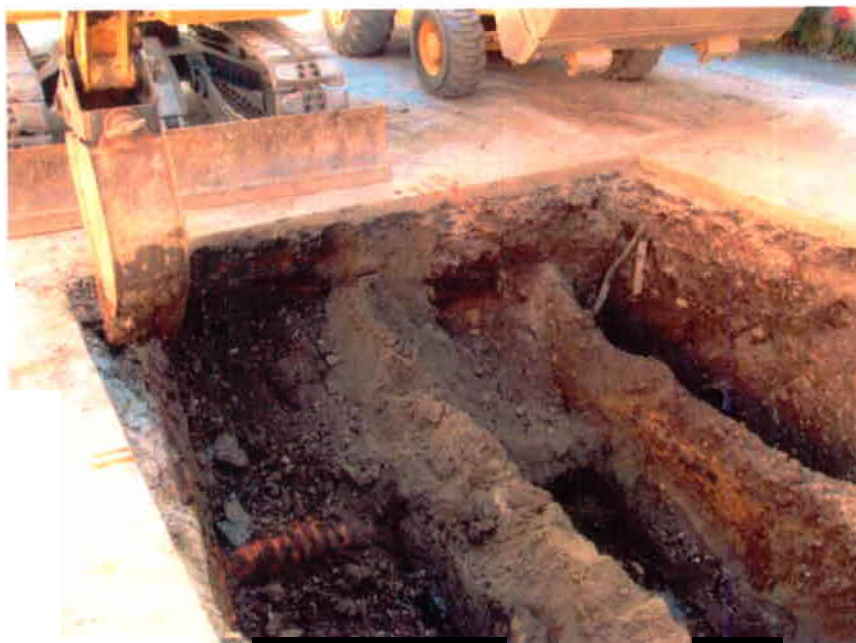
Photograph No. 019

Excavation EX3 showing corrugated steel drain pipe under water pipes.

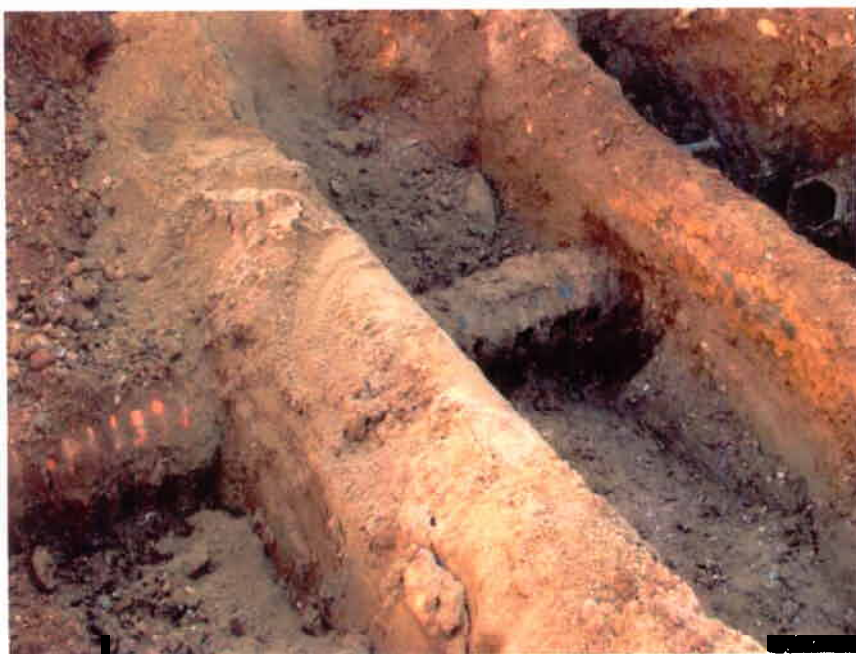
Photograph No. 020

Excavation EX3 showing holes in corrugated steel drain pipe.

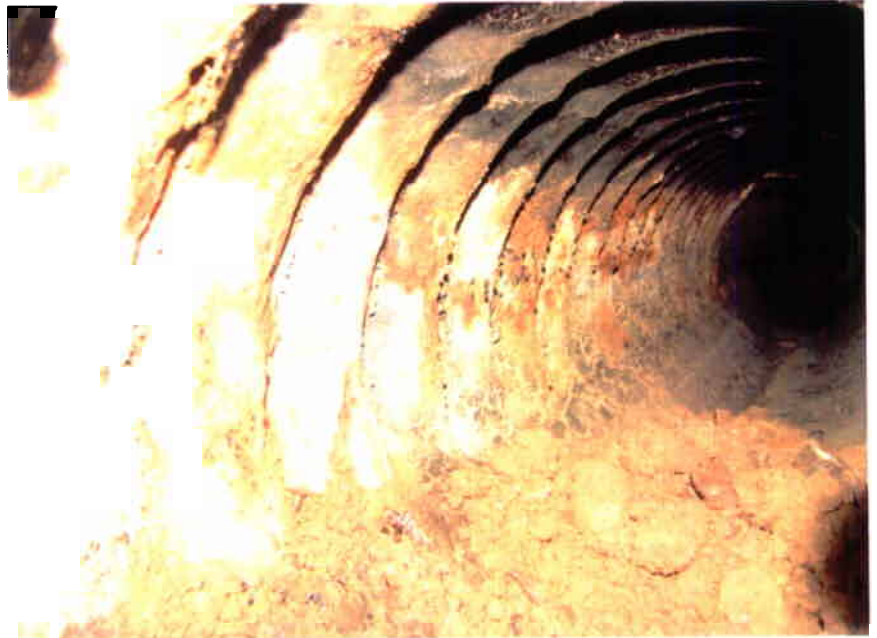
Photograph No. 021

Interior of corrugated steel drain pipe showing coating lining the bottom invert of pipe.

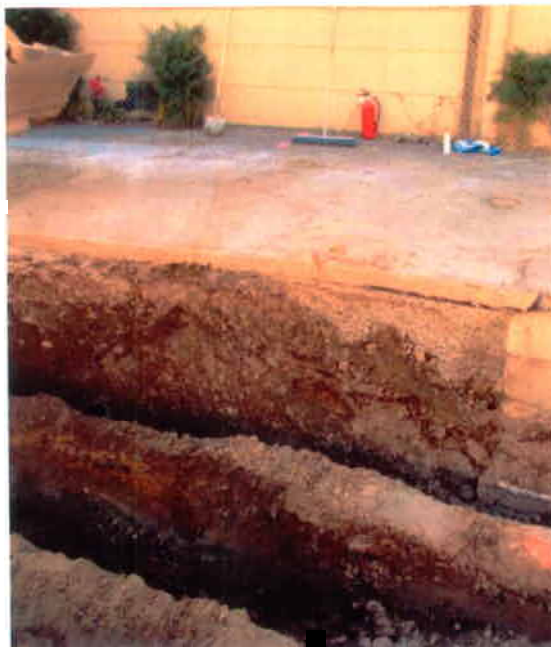
Photograph No. 022

Sample locations EX3-6 (south wall east) at 30 inches below ground surface and EX3-9 (floor sample east) at 60 inches below ground surface.

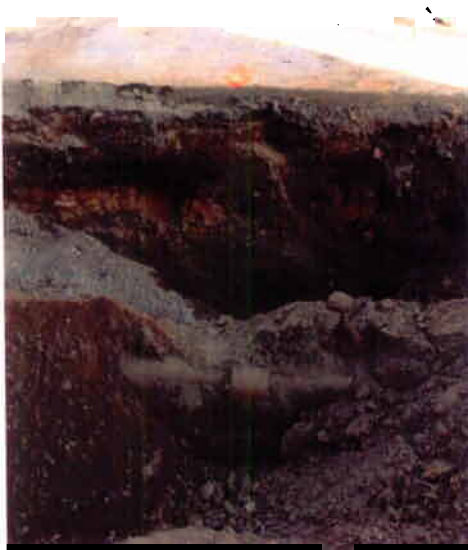
Photograph No. 023

Sample location EX3-4b (north wall east) at 30 inches below ground surface.

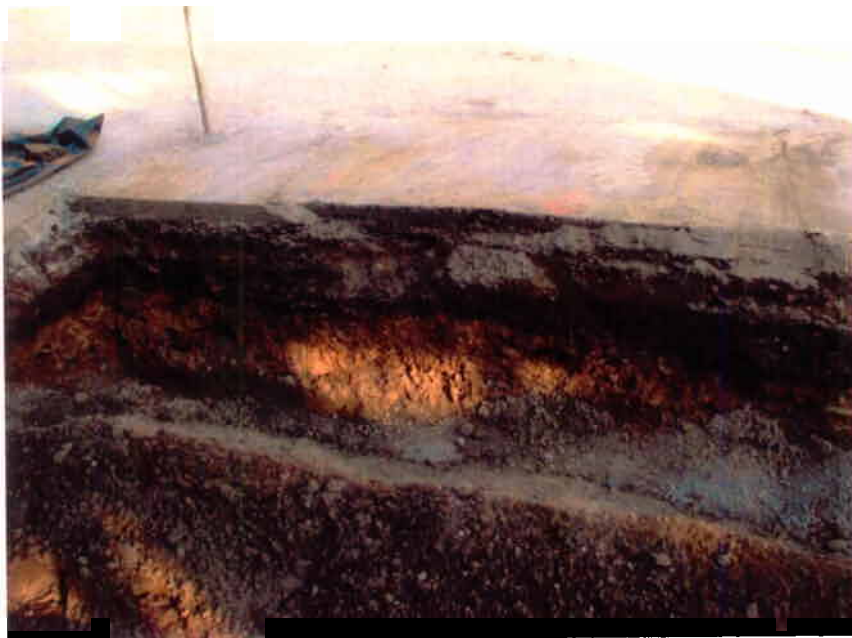
Photograph No. 024

Sample locations EX3-3c (north wall west) at 30 inches below ground surface and EX3-8 (floor sample west) at 60 inches below ground surface.

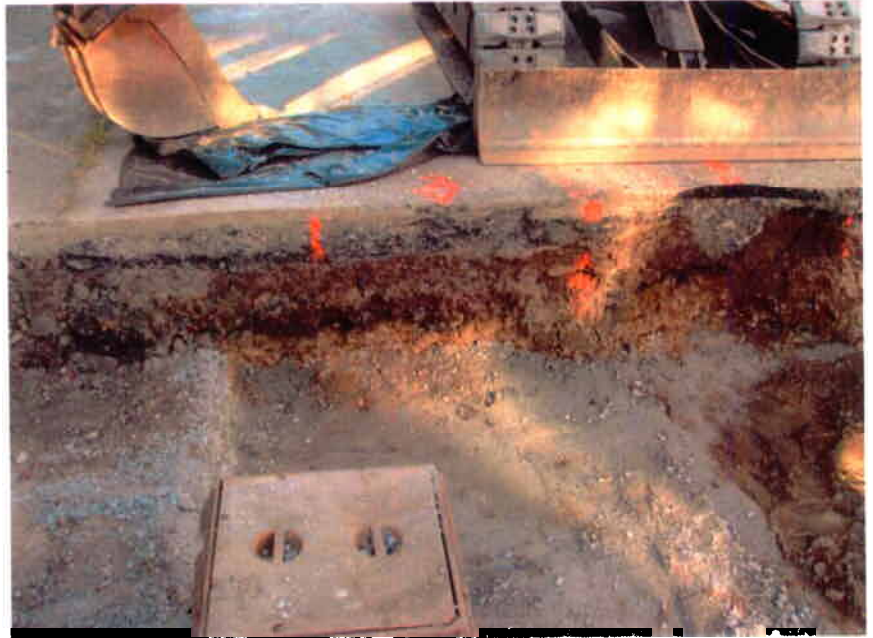
Photograph No. 025

Sample location EX3-2b (west wall) at 30 inches below ground surface. Note: excavation partially backfilled to stabilize excavation near building and water tank.

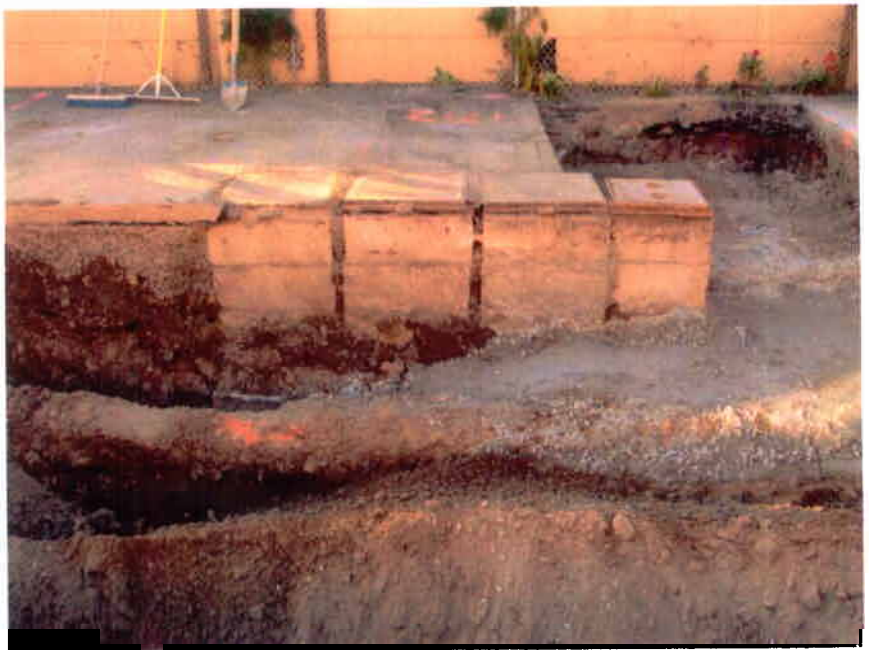
Photograph No. 026

Excavation EX3 showing exposed holding tank.
